## **SB-0365**

### **Insider – Ventless Donut Kiosk**

**Subject: Proper System Installation and  
Inspection of Control Heads.**

**Bulletin Number:** 2323

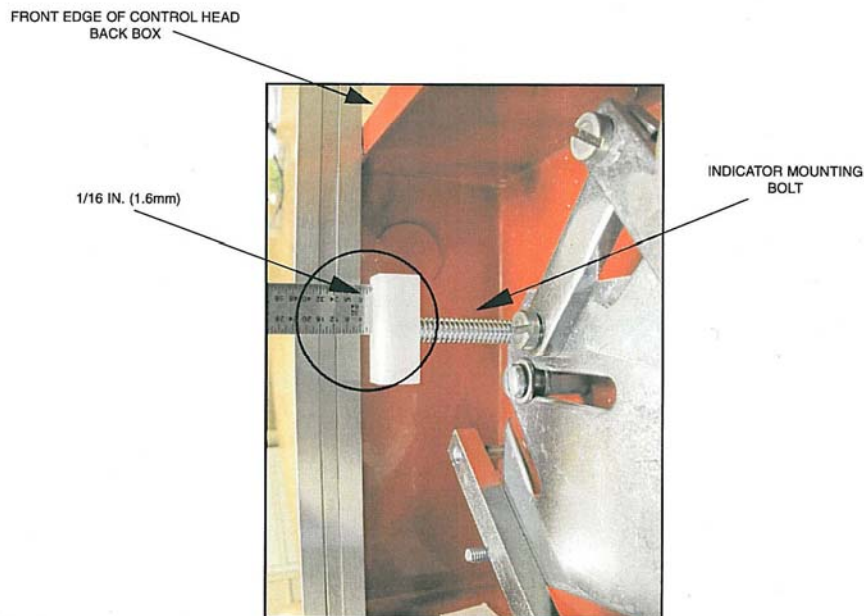
The system should be checked to make sure the white indicator tab is not binding on the cover assembly. Binding could cause the system to be inoperative.

As shown in the diagram below, turn the indicator mounting bolt until you have 1/16 in. (1.6 mm) clearance between the front edge of the control head back box and white indicator surface.
